Flood Control Project Maintenance
2012 Structure Summary Report
Overall Unit and Item Ratings

DWR Sacramento Maintenance Yard

Flood Control Project Maintenance**Unit Cover Sheet****2012 Structure Inspection Results****DWR Sacramento Maintenance Yard**

**Flood Control Project Maintenance
Levee Inspections**

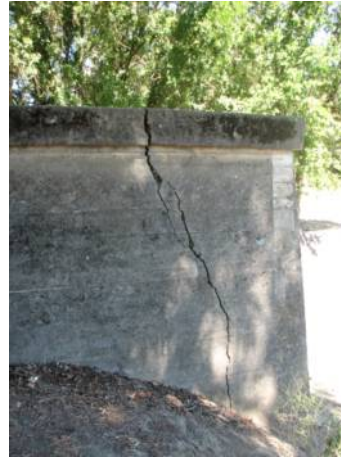
johngw_t_20120702_025.jpg

A crack runs top to bottom at the west end structure.

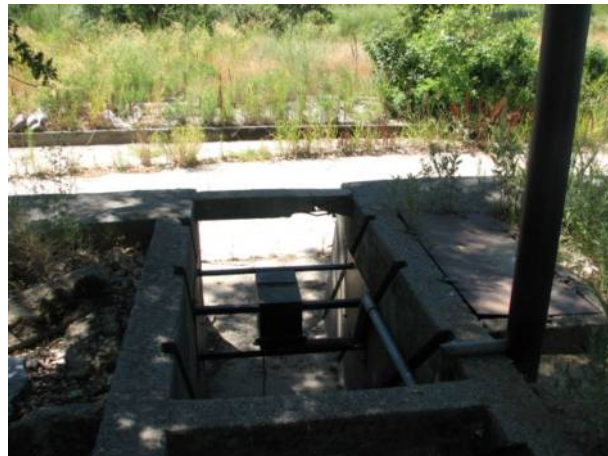
johngw_t_20120702_026.jpg

A view of the fish ladder some rebar is exposed on the cross bracing.

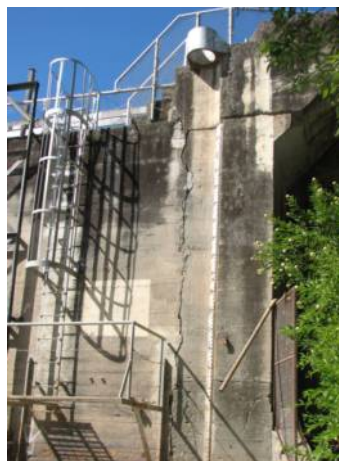
johngw_t_20120703_041.jpg

The crack at the north end of the structure has not changed from last year. Continue to monitor the crack and repair as necessary.

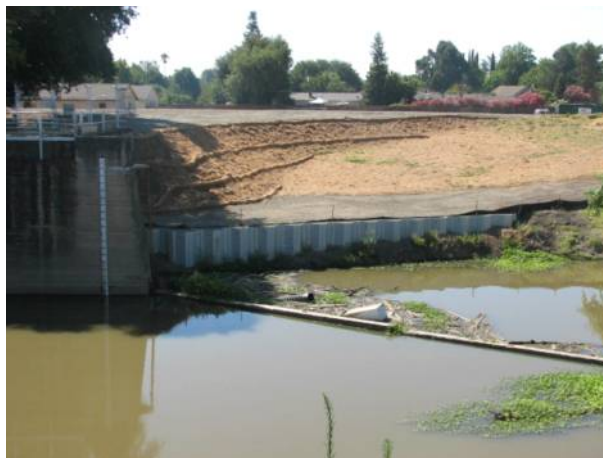
johngw_t_20120703_042.jpg

A new landing has been established for construction.

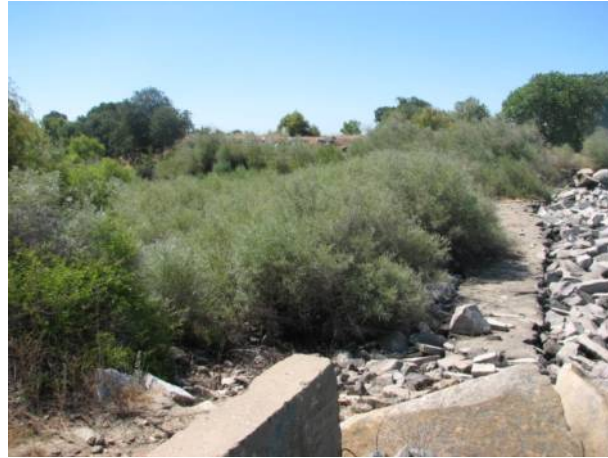
johngw_t_20120702_037.jpg

A view of the vegetation (sandbar willows) in front of the dam.

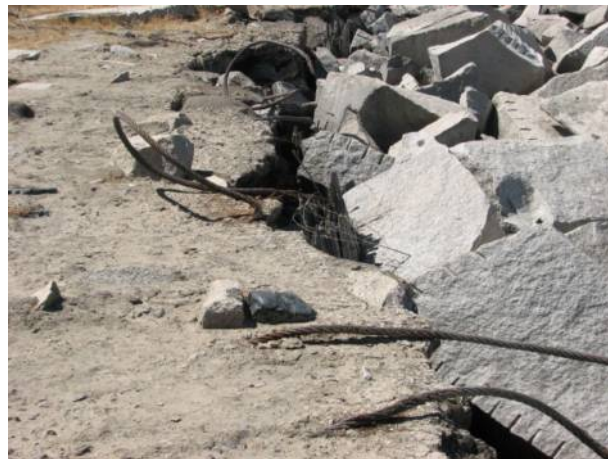
johngw_t_20120702_038.jpg

Cable sticking out from the dam and could be a hazard.

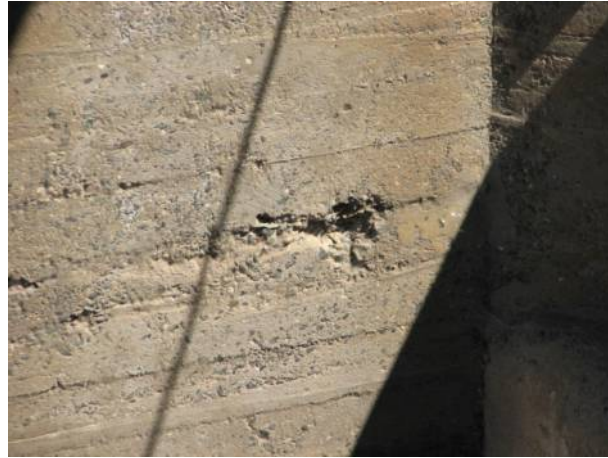
johngw_t_20120702_030.jpg

(Bay 48) Rebar is exposed in the side wall.

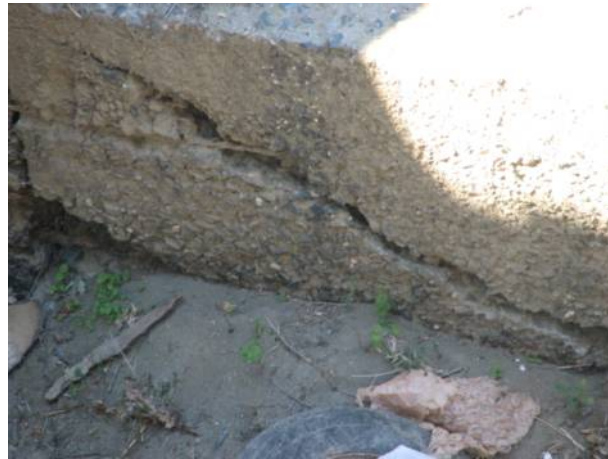
johngw_t_20120702_031.jpg

(Bay 48) A crack and rebar exposed.

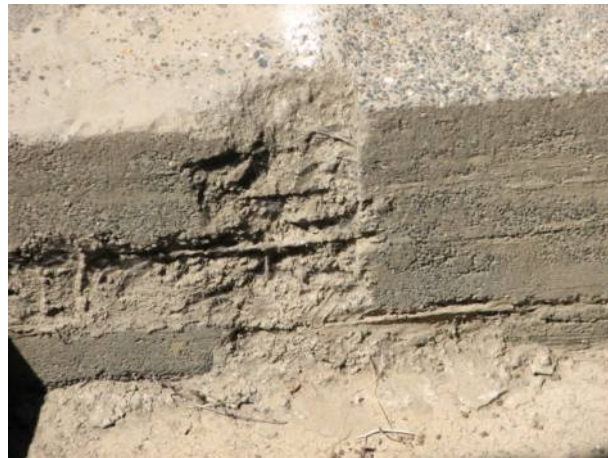
johngw_t_20120702_032.jpg

(Bay 14) Some rebar is exposed.

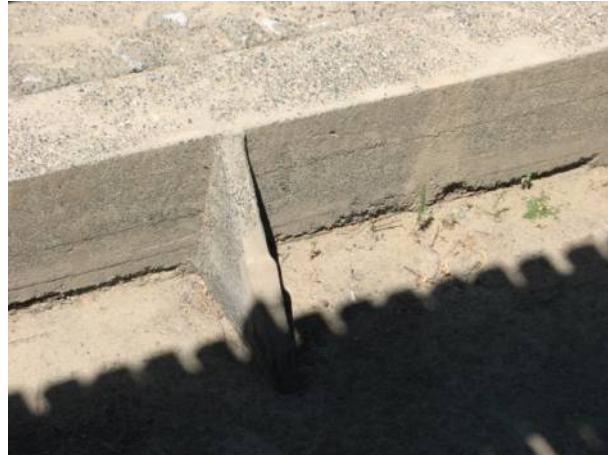
Levee Mile Report Line	1
Start Levee Mile	
End Levee Mile	
Location	Crown
Category	Structures
Item	Photo Documentation
(Bay 12) There is minor exposure at the base.	
johngw_t_20120702_033.jpg

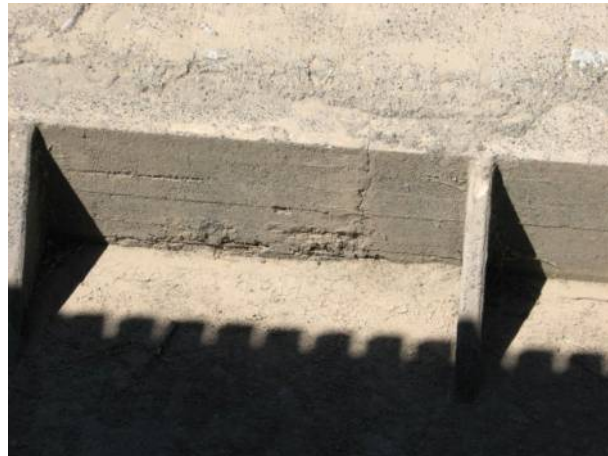
Levee Mile Report Line	1
Start Levee Mile	
End Levee Mile	
Location	Crown
Category	Structures
Item	Photo Documentation
(Bay 6) There is some rebar exposed.	
johngw_t_20120702_034.jpg

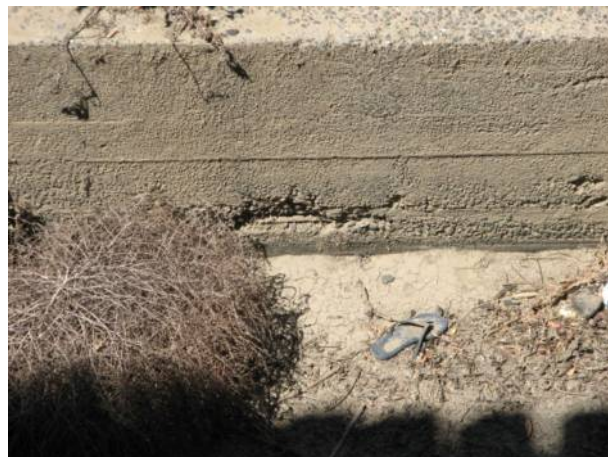
Levee Mile Report Line	1
Start Levee Mile	
End Levee Mile	
Location	Crown
Category	Structures
Item	Photo Documentation
(Bay 2) There is minor damage with some rebar exposed.	
johngw_t_20120702_035.jpg

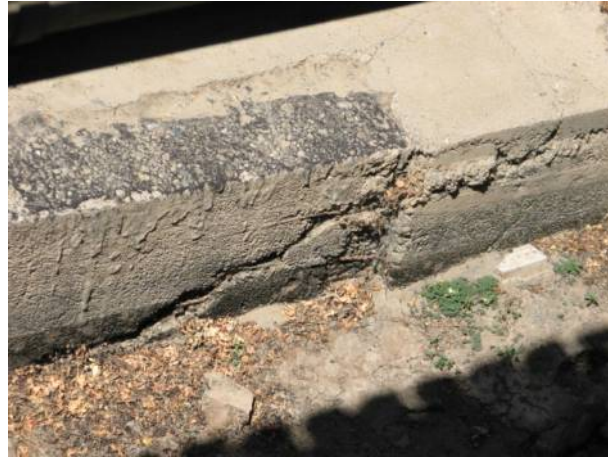
johngw_t_20120702_036.jpg

(Bay 1) There is some rebar exposed.
